## STM32WB10CC device errata

This document applies to STM32WB10CC devices and the device variants as stated in this page.

It gives a summary and a description of the device errata, with respect to the device datasheet and reference manual RM0478.

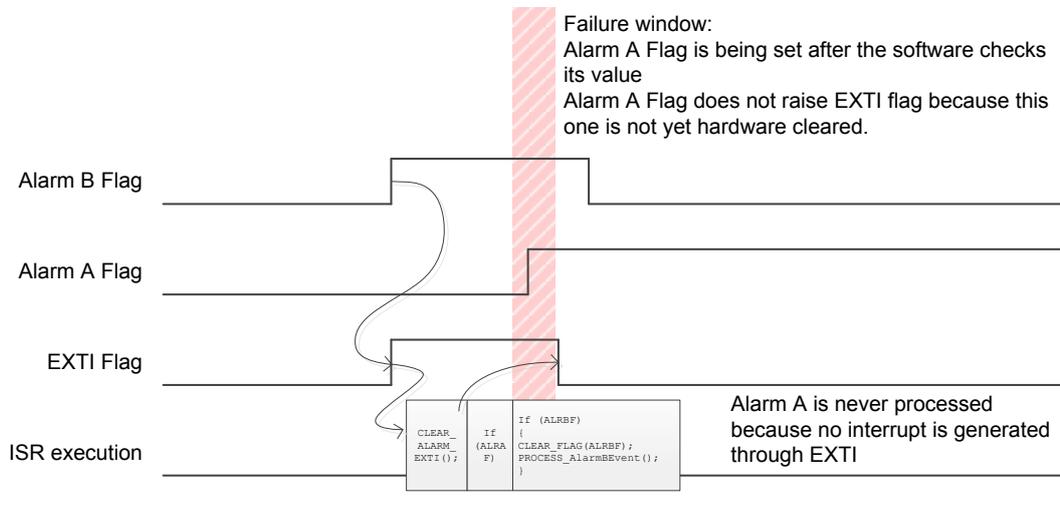
**Figure 1. Masked RTC interrupt**

The following code example and figure illustrate the failure mechanism: The Alarm A event is lost (fails to generate interrupt) as it occurs in the failure window, that is, after checking the Alarm A event flag but before the effective clear of the EXTI interrupt flag by hardware. The effective clear of the EXTI interrupt flag is delayed with respect to the software instruction to clear it.

In the interrupt service routine, apply three consecutive event flag checks - source one, source two, and source one again, as in the following code example:
