## dsPIC33EVXXXGM00X/10X Family Silicon Errata and Data Sheet Clarification

The dsPIC33EVXXXGM00X/10X family devices that you have received conform functionally to the current Device Data Sheet (DS70005144H), except for the anomalies described in this document.

The silicon issues discussed in the following pages are for silicon revisions with the Device and Revision IDs listed in [Table 1](#). The silicon issues are summarized in [Table 2](#).

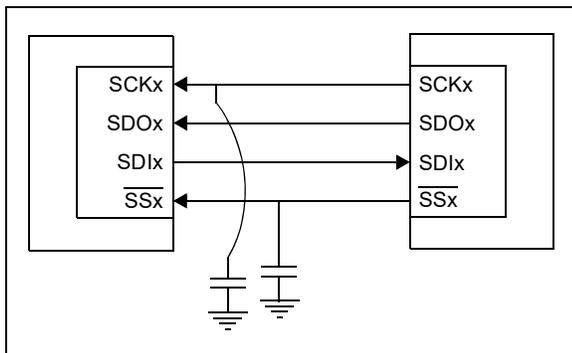
FIGURE 1:

When the SPIx module is configured in SPIx Slave mode (MSTEN bit (SPIxCON1[5]) = 0), the frame slave (FRMEN bit (SPIxCON2[15]) = 1) and the SPIFSD bit (SPIxCON2[14] = 1), in Standard Buffer mode with the Clock Polarity Select bit, CKP = 0, the data are not transmitted in both 8-bit and 16-bit mode, but the data are being received correctly.

Adding a capacitance on the signal, as shown in Figure 1, will help the data to be received properly.

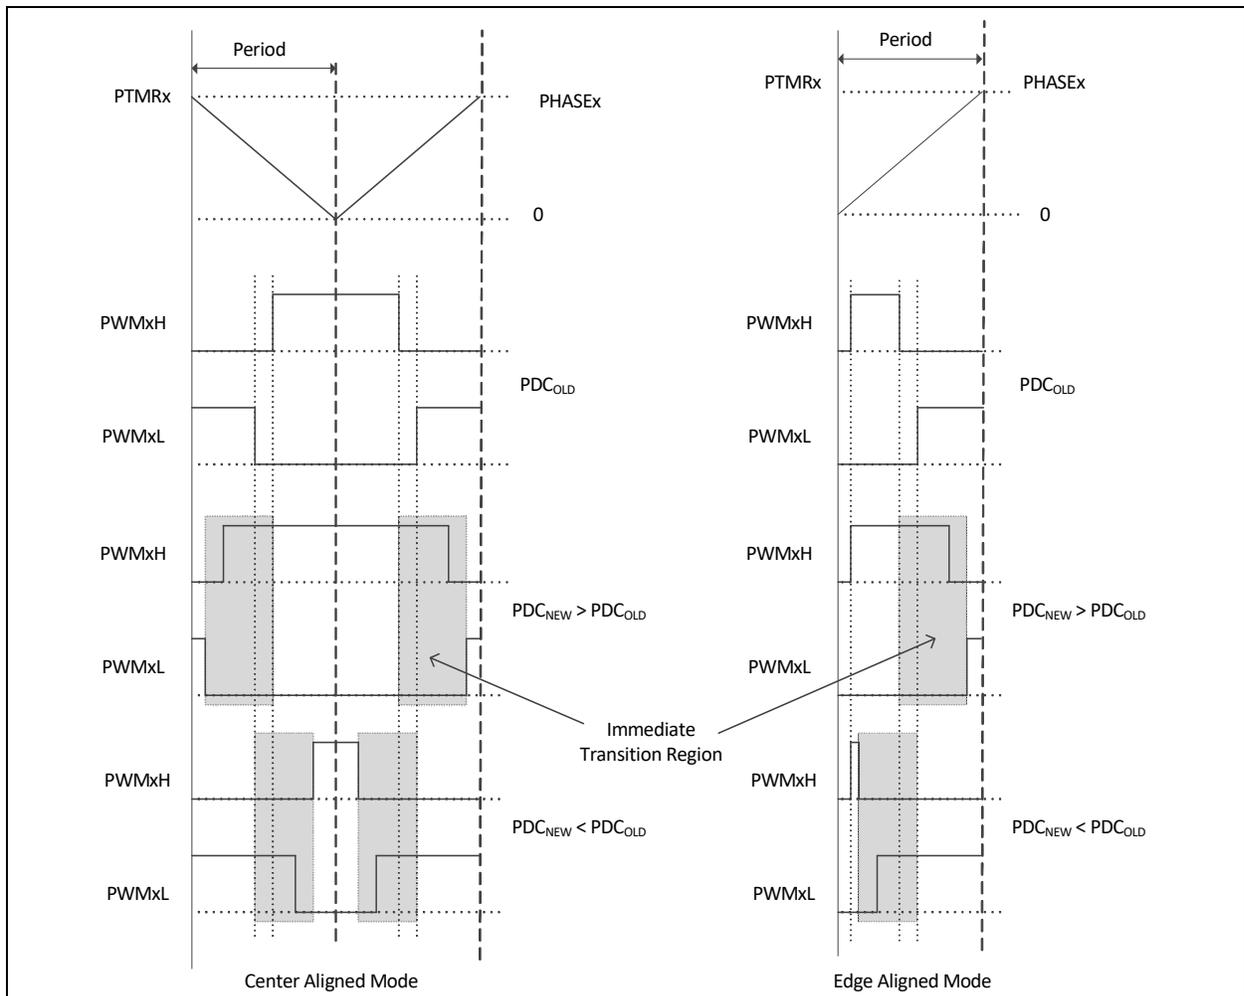
**FIGURE 2: TIMING DIAGRAMS FOR CENTER-ALIGNED AND EDGE-ALIGNED MODES**

The PWM generator may not assert dead time on the edges of transitions. This has been observed when all of the following conditions are present:

time base, will determine if the PWMxH and PWMxL outputs make an immediate transition. PWMxH and PWMxL outputs make an immediate transition if the Duty Cycle register is written with a new value, PDC<sub>NEW</sub>, at a point of time when the PWM time base is counting a value that is in between PDC<sub>NEW</sub> and PDC<sub>OLD</sub>. Additionally, writing to the Duty Cycle register, close to the instant of time where dead time is being applied, may result in a reduced dead time effective on the PWMxH and PWMxL transition edges.

In [Figure 2](#), if the duty cycle write occurred in the shaded box, then PWMxH and PWMxL will make an immediate transition without dead time.

However, in most applications, the duty cycle update timing can be controlled using the TRIGx trigger or Special Event Trigger, such that the above mentioned conditions are avoided altogether.

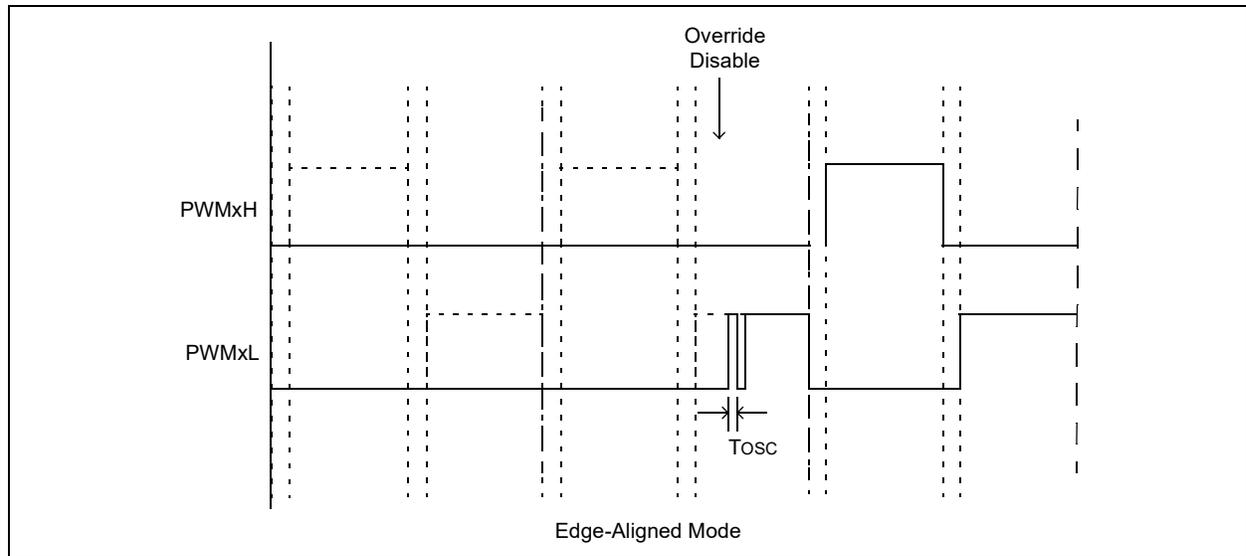
FIGURE 3: ILLUSTRATION OF 1 TOSC GLITCH WHEN PWM OVERRIDE IS TURNED OFF

In Complementary mode after the PWM module is enabled ( $PTEN = 1$ ), if the PWM override is turned off, a one TOSC glitch will be present on the rising edge of either the PWMxH or PWMxL pins, whichever occurs first, as shown in Figure 3.

The glitch will be present on PWMxH/PWMxL every time the override state is changed from override enabled to override disabled. The width of this glitch is equal to one TOSC when  $PCLKDIV[2:0]$  ( $PTCON2[2:0]$ ) = 000. Increasing the PWMx input clock prescaler setting will increase the width of the glitch accordingly.

Since the width of the glitch is just one TOSC at higher values of FOSC, the glitch may not be visible on the PWMxH/PWMxL pins due to pin and PCB trace capacitances.

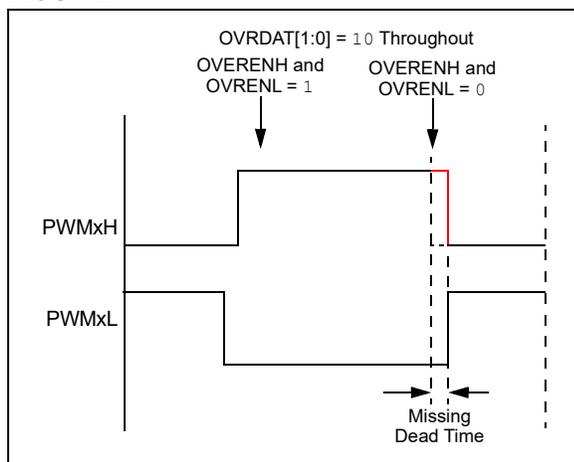
FIGURE 4:

In Complementary Output mode, the expected dead time between transitions of the PWMxH and PWMxL outputs may not be asserted when the following occurs:

- Output override synchronization is configured to occur on the CPU clock boundary (IOCONx[0] = 0);
- Both PWMxH and PWMxL overrides are enabled prior to the event (OVRENH and OVRENL are both '1'), and
- Both overrides are disabled (OVRENH and OVRENL are both '0') at the instant the dead time should be asserted (Figure 4). This has been observed in both Center-Aligned and Edge-Aligned modes.

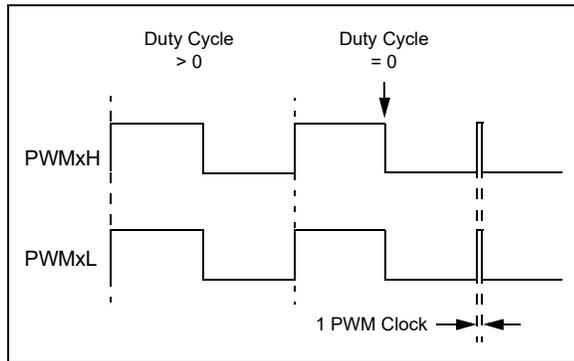
FIGURE 5:

In the Redundant Output mode (IOCONx[11:10] = 10) and Push-Pull Output mode (IOCONx[11:10] = 01) with Immediate Update disabled (PWMCONx[0] = 0), when the Duty Cycle register is updated from a non-zero value to zero, a glitch pulse of a width equal to one PWM clock will appear at the next PWM period boundary, as shown in Figure 5, for the Redundant Output mode. Here, the Duty Cycle register refers to the PDCx register if PWMCONx[8] = 0 or the MDC register if PWMCONx[8] = 1.

If the application requires a zero duty cycle output, there are two possible work around methods:

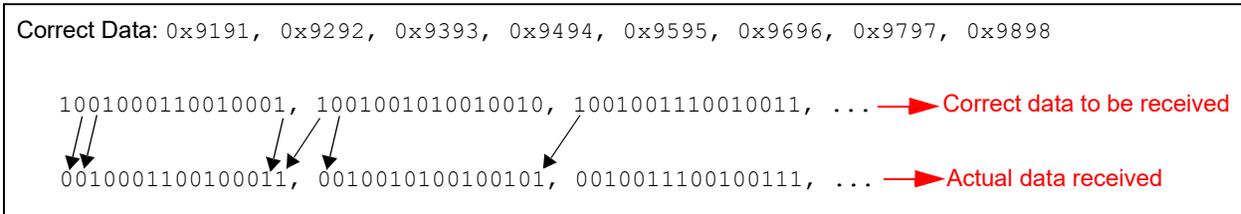
**FIGURE 6:**

Received data of the SPI are sampled one clock cycle late for the following conditions:

For example, the correct data that should be received are 0x9191, 0x9292, 0x9393, 0x9494, 0x9595, 0x9696, 0x9797, 0x9898, but the actual data received are 0x2323, 0x2525, 0x2727, 0x2929, 0x2B2B, 0x2D2D, 0x2F2F, 0x3130 (Figure 6).

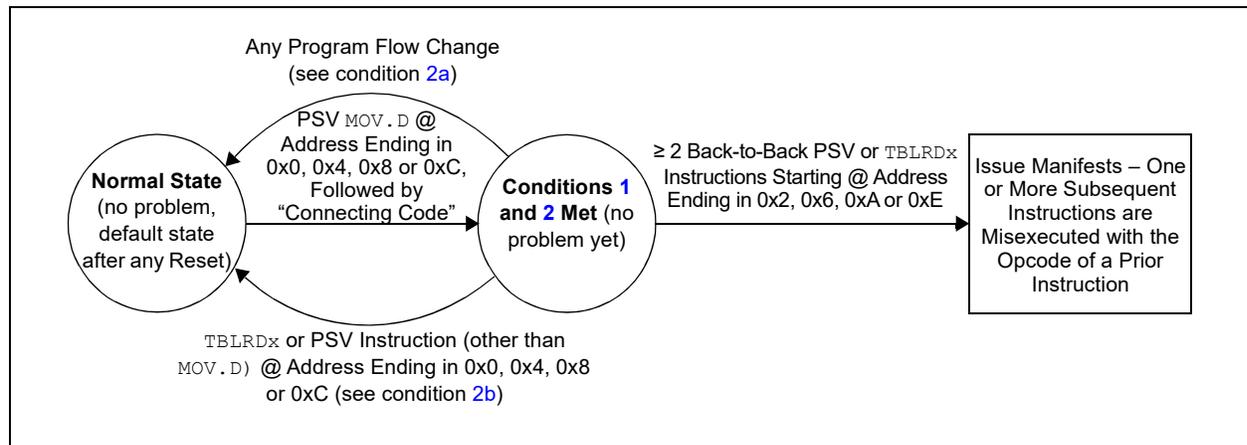
**FIGURE 7: SIMPLIFIED BEHAVIOR**

When two or more data Flash read instructions (via Program Space Visibility (PSV) read or table read) are executed back-to-back, one or more subsequent instructions can be misexecuted when all of the conditions in [Table 6](#) occur.

[Figure 7](#) provides an example of the effective behavior.

1. All instances of PSV `MOV.D` can be replaced with two PSV `MOV` instructions instead. Non-PSV `MOV.D` instructions acting on RAM/SFRs do not need to be modified; or
2. If not already present, a program flow change instruction (such as `BRA $+2`) can be inserted above back-to-back data Flash read sequences; or
3. Back-to-back data Flash read instruction sequences can be broken up by inserting a non-Flash read instruction (such as a `NOP`), in between the Flash read instructions; or
4. The alignment of the code can be shifted to avoid the required opcode location addresses.
